TIMKEN®

Engineered Surfaces

The Solution to Your Bearing Damage Problems

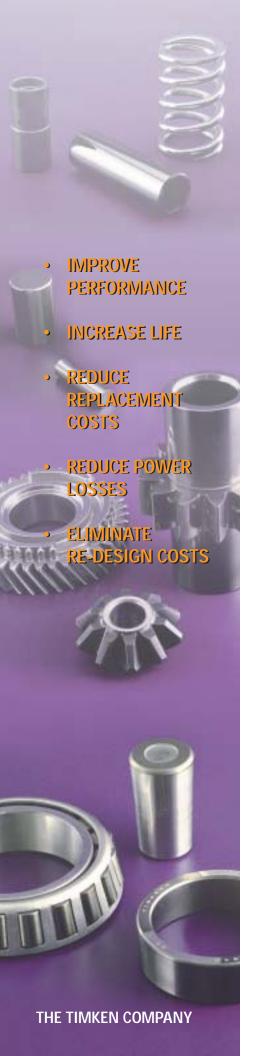
INADEQUATE LUBRICATION*

Roller end scoring - Metal-to-metal contact from breakdown of lubricant film.

heat damage from metal-to-metal contact.

Bruising – Debris from other fatigued parts, inadequate sealing, or poor maintenance.

Abrasive wear - Fine abrasive particle contamination.

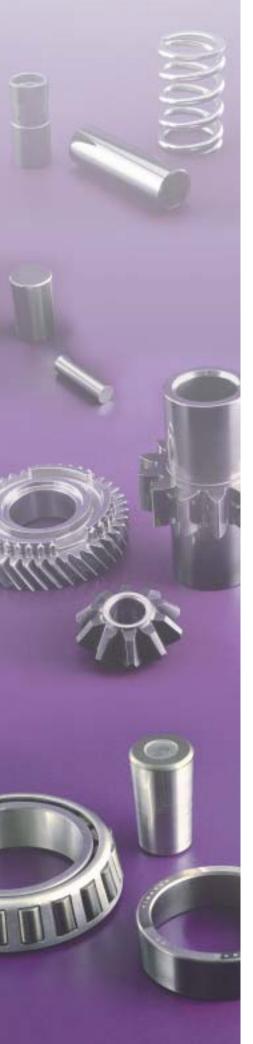
PEELING

Micro-spalling due to thin lubricant film from high loads/low RPM or elevated temperatures.

Adhesive wear and smearing damage leading to course grain fatigue spalling. Typically caused by roller skidding under slow speed and thin film lubrication.

Point surface origin – Spalling from debris or raised metal exceeding the lubricant film thickness.
